Manhole Inspection Summary

Manhole # S31E__032MH

Insp Date: **12/16/08 11:02 AM**

Location Address: **128 N Paca St**

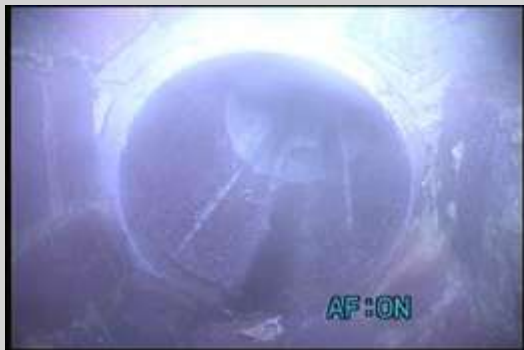
12 O'Clock Outflow

8 in. Circular Gravity Sewer
Pipe Out @ 12 O'Clock

Infiltration: **None** Pipe Seal Cond: **Sound**

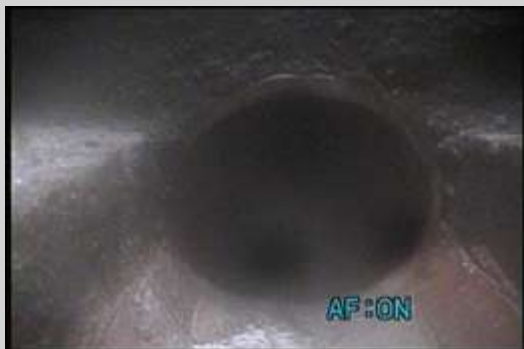
3 O'Clock Inflow

8 in. Circular Gravity Sewer
Pipe In @ 3 O'Clock

Infiltration: **None** Pipe Seal Cond: **Sound**
